Effect of Intake Air Filter Condition on Vehicle Fuel Economy

**EFFECT OF INTAKE AIR FILTER CONDITION ON
VEHICLE FUEL ECONOMY**

Date Published: February 2009

Prepared by
OAK RIDGE NATIONAL LABORATORY
Oak Ridge, Tennessee 37831-6283
managed by
UT-BATTELLE, LLC
for the
U.S. DEPARTMENT OF ENERGY
under contract DE-AC05-00OR22725

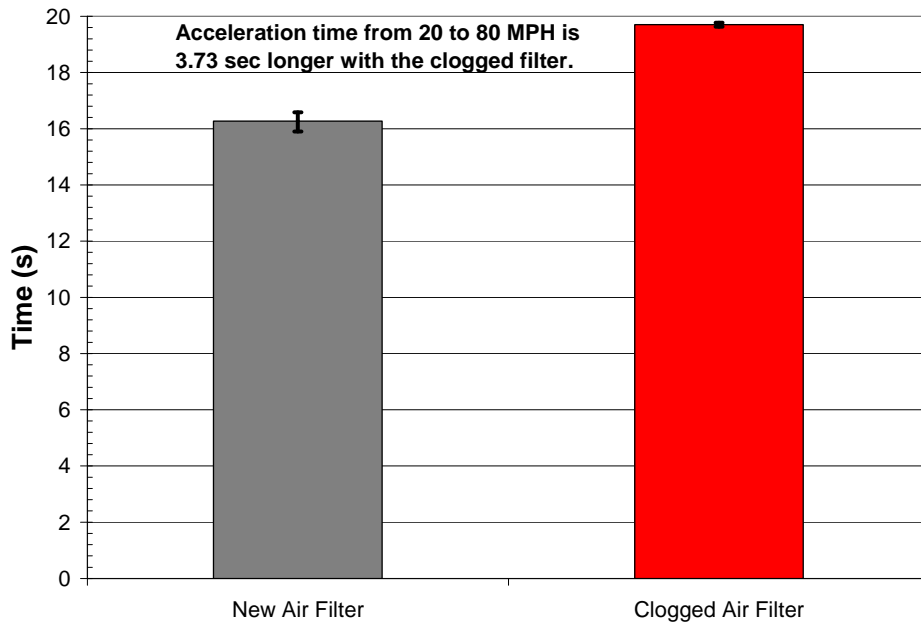
Fig. 3.15. Acceleration time for 1972 Pontiac Grandville during WOT tests.

Data are averaged over the three CRC-E60 accelerations from 20 to 80 mph with the throttle at 100%. Range bars show the minimum and maximum for each data set.

Figure 3.15 shows that in the clogged filter scenario, the average time it took to accelerate from 20 to 80 mph during the WOT tests increased by about 3.73 seconds or 23%. The driver reported a noticeable loss of performance during the WOT testing with the simulated clogged filter.
