Effect of Intake Air Filter Condition on Vehicle Fuel Economy

**EFFECT OF INTAKE AIR FILTER CONDITION ON
VEHICLE FUEL ECONOMY**

Date Published: February 2009

Prepared by
OAK RIDGE NATIONAL LABORATORY
Oak Ridge, Tennessee 37831-6283
managed by
UT-BATTELLE, LLC
for the
U.S. DEPARTMENT OF ENERGY
under contract DE-AC05-00OR22725

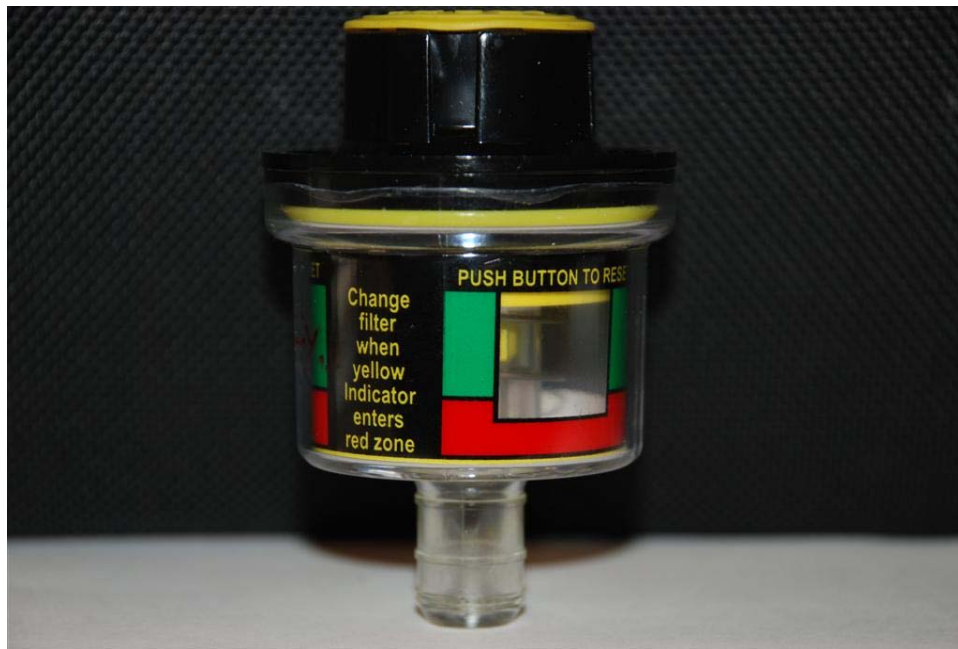
Fig. 2.2. Air filter indicator.

A factory OEM indicator was taken from a 2001 Chevrolet Silverado with 5.3L V8 and tested to find the Outlet DP required to “set” the indicator or move the yellow indicator into the red zone (see Fig. 2.2). Using a vacuum pump and water manometer to test the indicator, the authors determined that an Outlet DP of about 5.7 kPa was needed to set the indicator to the level corresponding to a clogged air filter.

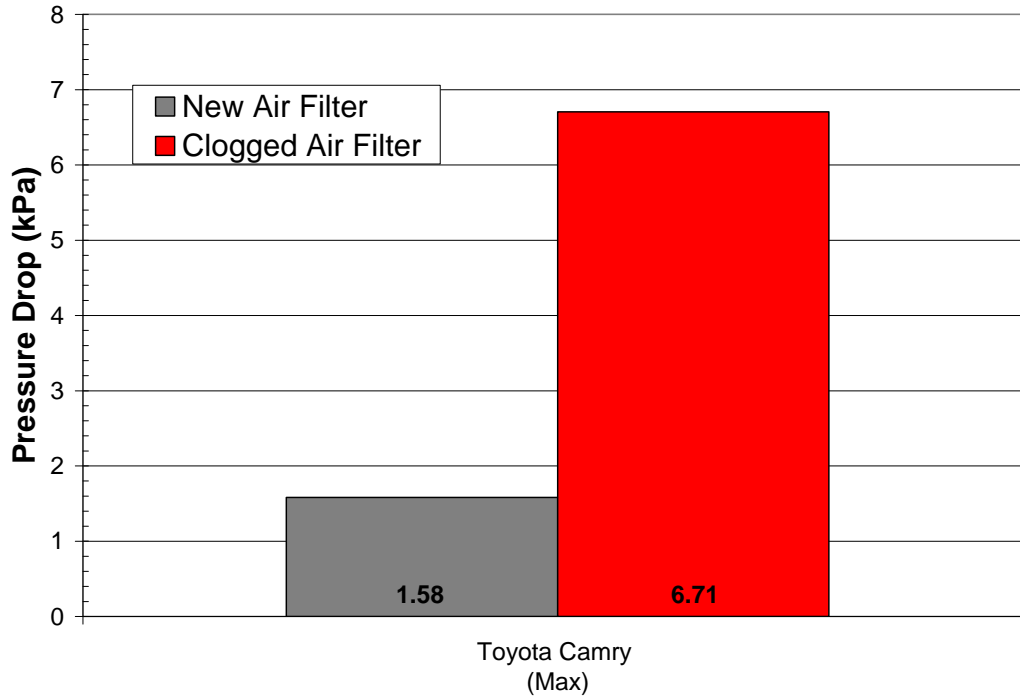
Fig. 3.3. Average maximum Outlet DP for the 2003 Toyota Camry during the CRC E-60 WOT tests.

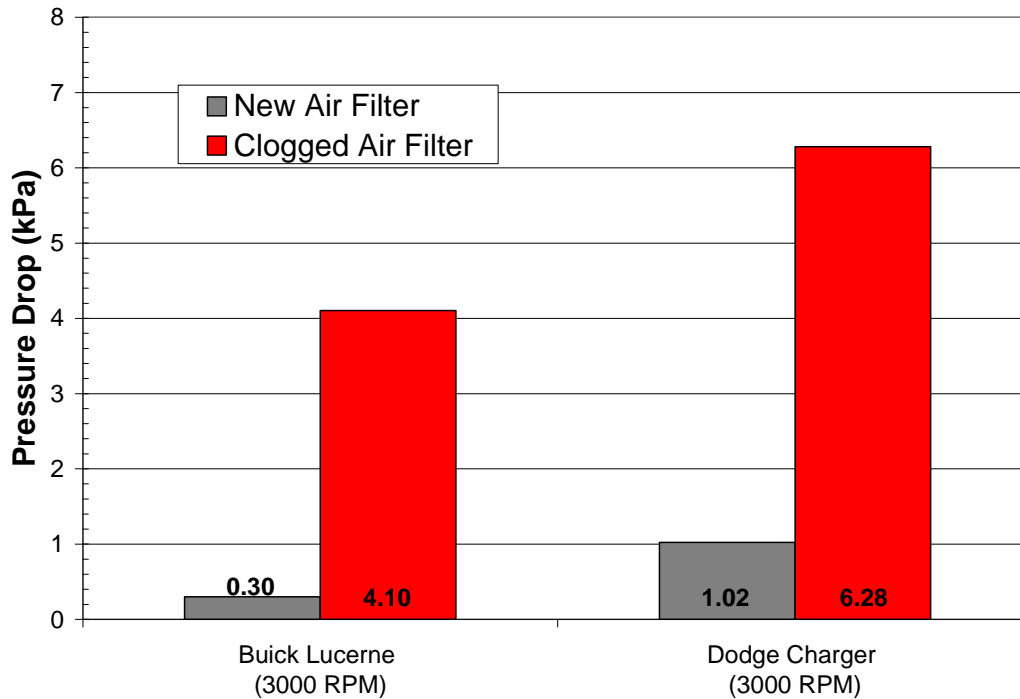
Fig. 3.4. Average Outlet DP at 3000 RPM during the CRC E-60 WOT tests.

Because the peak Outlet DP for the Charger and Lucerne were outside the range of the sensor in the clogged state, the average of the Outlet DPs at 3000 RPM, recorded for each of the WOT accelerations

during the CRC E-60 WOT section of the test, was used to compare these vehicles, as shown in Fig. 3.4. The Outlet DP values for the SS WOT tests were all within the range of the sensor and are shown in Fig. 3.5.

For the Lucerne, the Outlet DP at 3000 RPM during the initial acceleration of the CRC E-60 WOT tests was in excess of 4 kPa for the clogged filter and less than 0.4 kPa for the new filter (Fig. 3.4). During the SS WOT tests the clogged filter created an Outlet DP in excess of 5.7 kPa, while the new filter Outlet DP was less than 0.9 kPa (Fig. 3.5).

For the Charger, the Outlet DP at 3000 RPM during the initial acceleration of the CRC E-60 WOT tests was in excess of 6.2 kPa for the clogged filter, while that for the new filter was less than 1.1 kPa under the same acceleration conditions (Fig. 3.4). During the SS WOT tests the clogged filter created an Outlet DP in excess of 7.2 kPa, while the new filter Outlet DP was less than 1.2 kPa under the same acceleration conditions (Fig. 3.5).

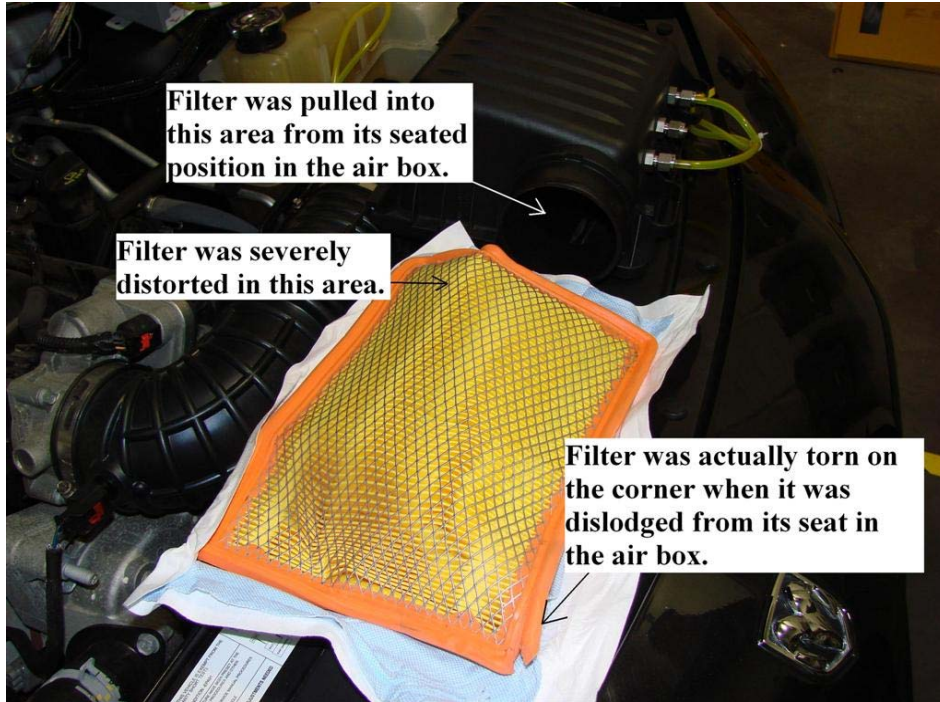
Fig. 3.6. Air filter damage from WOT testing 2006 Dodge Charger. Filter was damaged due to the pressure drop across the filter, resulting in the filter being torn out of its seat in the air box.

Also, for the Charger, under these acceleration conditions with the filter clogged, the pressure drop was so severe that the air filter was actually dislodged from its position in the air cleaner box and pulled into the intake hose. Fig. 3.6 shows the damage that was done to the air filter as a result of these clogged air filter WOT tests.

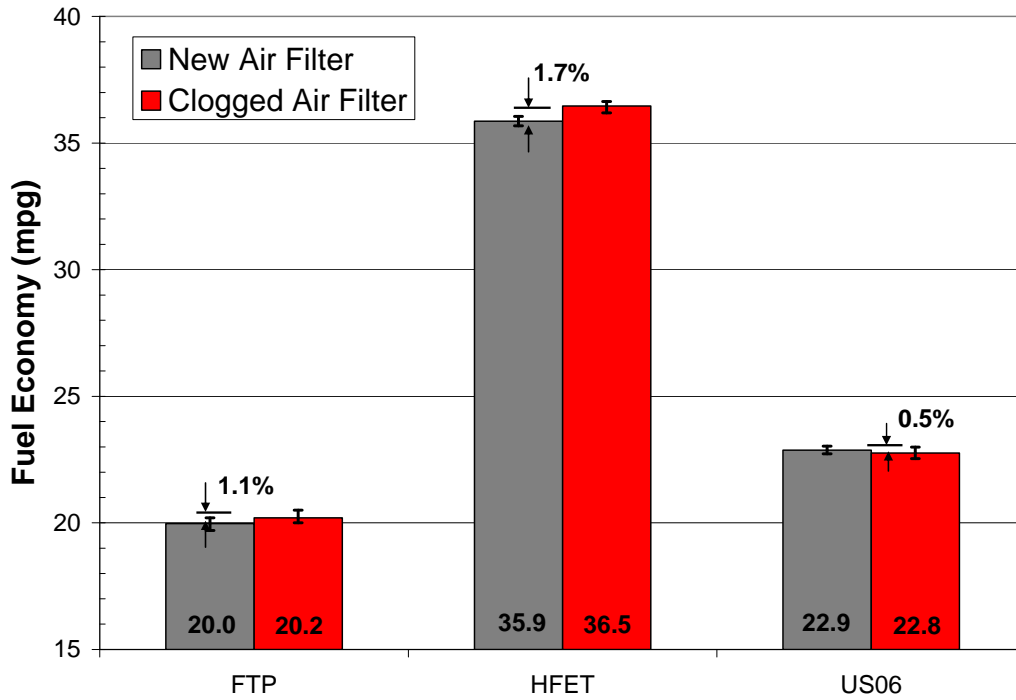
Fig. 3.9. Fuel economy for 2007 Buick Lucerne. Data are averaged over the four tests conducted for each cycle and configuration. Range bars show the minimum and maximum for each data set.

Despite the filter restrictions, however, no significant changes in fuel economy were observed. Each vehicle was run through at least three rounds of FTP, HFET, and US06 tests with the new air filter, and the same protocol was repeated with the clogged air filter. The tests were conducted on consecutive days for each vehicle. This format was used to allow for the required soak time to perform a cold FTP each morning. The resulting fuel economy data for the vehicles are shown in Figs. 3.8, 3.9, and 3.10. Range bars in the figures show the minimum and maximum of the tests for each case, while the columns show the average. Test-to-test repeatability is within about 1.5%, and all of the variances between the new and clogged air filter cases are similarly within about 1.7%. The baseline fuel economies for the vehicles were all within 0–6% of unadjusted EPA certification database values (www.epa.gov) for similar vehicles.

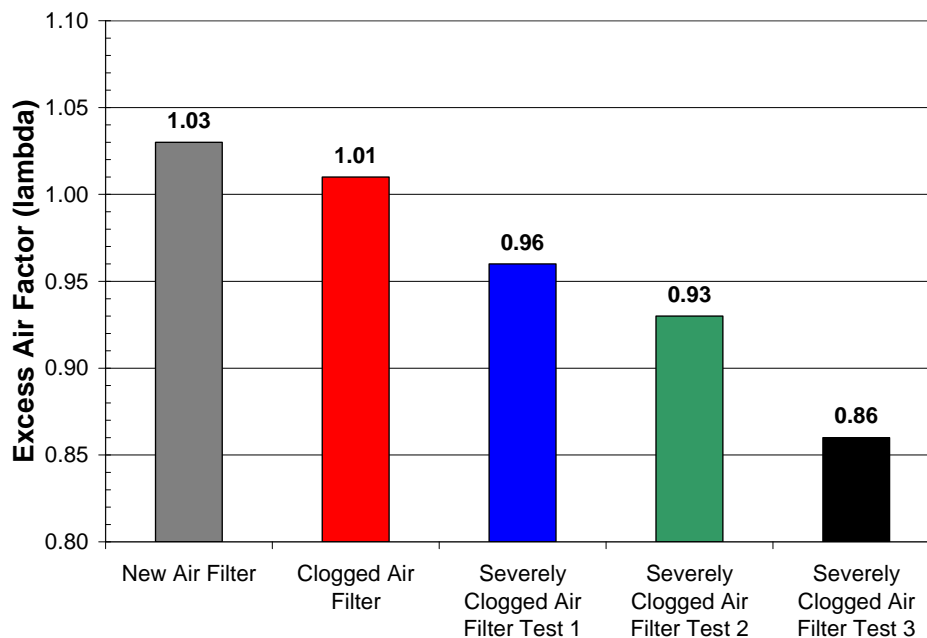
Fig. 3.21. Average double HFET lambda for 1972 Pontiac Grandville.

The restriction for Severely Clogged Air Filter Test 3 was so severe that the vehicle would not accelerate past about 70–75 mph, and the driver had to consciously control the rate of change of the throttle to avoid rich misfire conditions. The HFET, like all certification tests, requires that the vehicle be operated over a defined cycle. If the vehicle is unable to meet the speed and acceleration requirements of the cycle, the test is deemed invalid. The maximum speed of the HFET cycle is about 60 mph, and further restriction would not allow the vehicle to meet the accelerations required during the cycle, invalidating the test. Therefore, this level of restriction was determined as the maximum possible restriction that could be tested. Figure 3.21 shows the average lambda (actual AFR divided by stoichiometric AFR) for the double HFETs conducted. The severely clogged air filter results in a much richer AFR (lambda < 1 = rich, lambda > 1 = lean). The trace file collected for the severely clogged filter test runs showed rich excursions to nearly 0.60 lambda during some of the accelerations of the cycle.
