Effect of Intake Air Filter Condition on Vehicle Fuel Economy

**EFFECT OF INTAKE AIR FILTER CONDITION ON
VEHICLE FUEL ECONOMY**

Prepared by
OAK RIDGE NATIONAL LABORATORY
Oak Ridge, Tennessee 37831-6283
managed by
UT-BATTELLE, LLC
for the
U.S. DEPARTMENT OF ENERGY
under contract DE-AC05-00OR22725

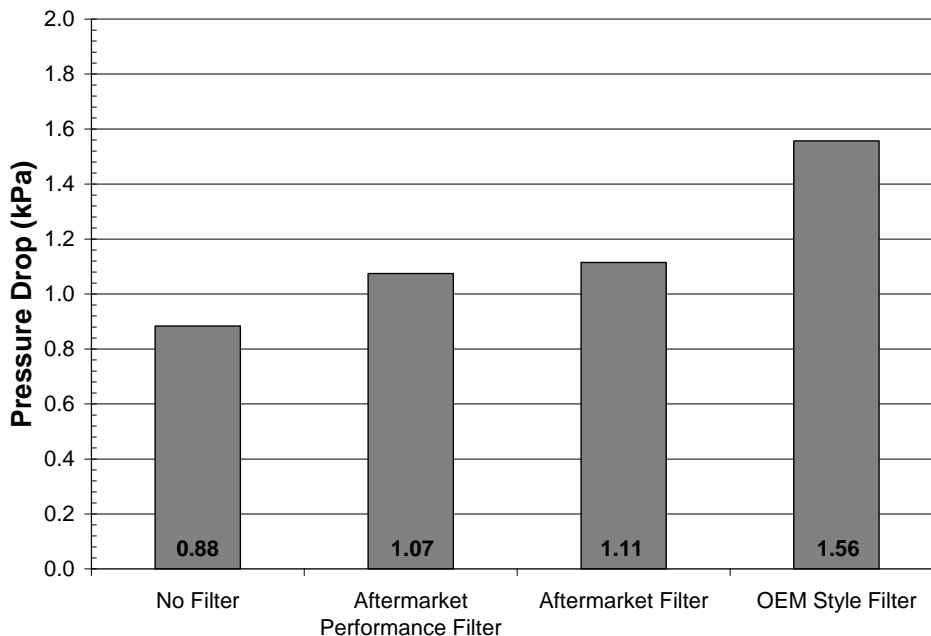
Fig. 3.1. Maximum Outlet DP for 2007 Buick Lucerne baselined clean air filters. Initial testing done to baseline multiple clean air filters.

Four filter setups, an OEM filter, an aftermarket filter, a performance aftermarket filter, and no filter, were tested, using the 2007 Buick Lucerne as the test vehicle, to determine a baseline and the filter to be used for the remainder of the testing. Each setup was tested over the WOT cycle described previously. It was observed that the OEM filter resulted in a higher Outlet DP than the aftermarket filter and the performance aftermarket filter, as is shown in Fig. 3.1. The aftermarket filter was chosen for the test process due to its lower initial Outlet DP compared to the OEM filter and because it is more common than the performance aftermarket filter; thus, it allowed us to explore the largest clean-to-clogged difference for a commonly used air filter. No measureable differences were observed in vehicle performance with these filters over the CRC E-60 WOT test cycle.
