Effect of Intake Air Filter Condition on Vehicle Fuel Economy

February 2009

Energy and Transportation Science Division

Prepared by
OAK RIDGE NATIONAL LABORATORY
Oak Ridge, Tennessee 37831-6283
managed by
UT-BATTELLE, LLC
for the
U.S. DEPARTMENT OF ENERGY
under contract DE-AC05-00OR22725

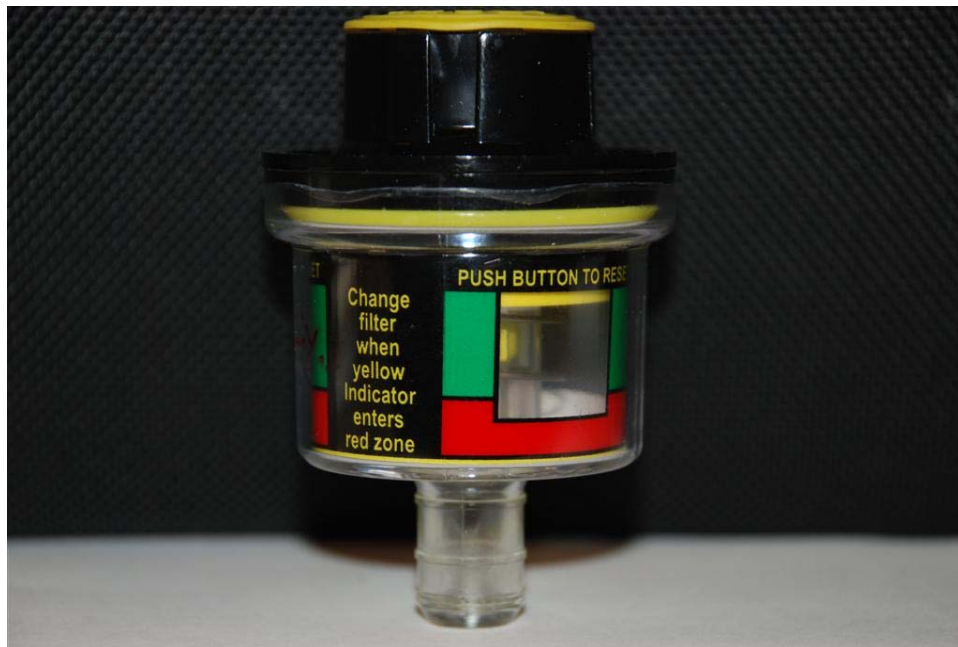
Fig. 2.2. Air filter indicator.

A factory OEM indicator was taken from a 2001 Chevrolet Silverado with 5.3L V8 and tested to find the Outlet DP required to “set” the indicator or move the yellow indicator into the red zone (see Fig. 2.2). Using a vacuum pump and water manometer to test the indicator, the authors determined that an Outlet DP of about 5.7 kPa was needed to set the indicator to the level corresponding to a clogged air filter.

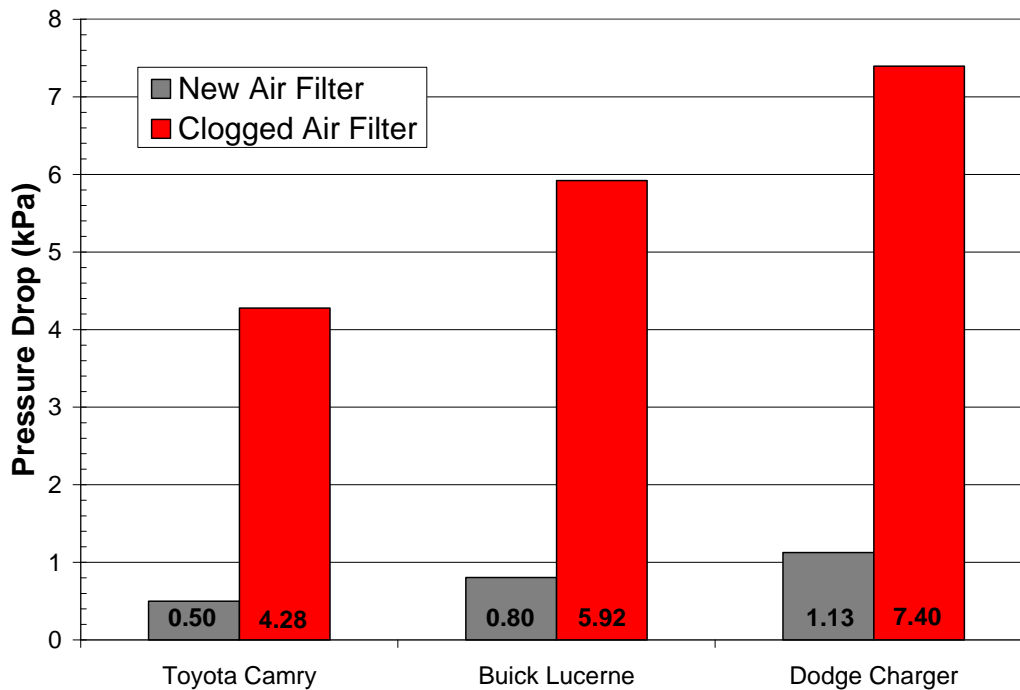
Fig. 3.5. Average maximum Outlet DP for SS WOT tests.

during the CRC E-60 WOT section of the test, was used to compare these vehicles, as shown in Fig. 3.4. The Outlet DP values for the SS WOT tests were all within the range of the sensor and are shown in Fig. 3.5.

For the Lucerne, the Outlet DP at 3000 RPM during the initial acceleration of the CRC E-60 WOT tests was in excess of 4 kPa for the clogged filter and less than 0.4 kPa for the new filter (Fig. 3.4). During the SS WOT tests the clogged filter created an Outlet DP in excess of 5.7 kPa, while the new filter Outlet DP was less than 0.9 kPa (Fig. 3.5).

For the Charger, the Outlet DP at 3000 RPM during the initial acceleration of the CRC E-60 WOT tests was in excess of 6.2 kPa for the clogged filter, while that for the new filter was less than 1.1 kPa under the same acceleration conditions (Fig. 3.4). During the SS WOT tests the clogged filter created an Outlet DP in excess of 7.2 kPa, while the new filter Outlet DP was less than 1.2 kPa under the same acceleration conditions (Fig. 3.5).
