Effect of Intake Air Filter Condition on Vehicle Fuel Economy

**EFFECT OF INTAKE AIR FILTER CONDITION ON
VEHICLE FUEL ECONOMY**

Prepared by
OAK RIDGE NATIONAL LABORATORY
Oak Ridge, Tennessee 37831-6283
managed by
UT-BATTELLE, LLC
for the
U.S. DEPARTMENT OF ENERGY
under contract DE-AC05-00OR22725

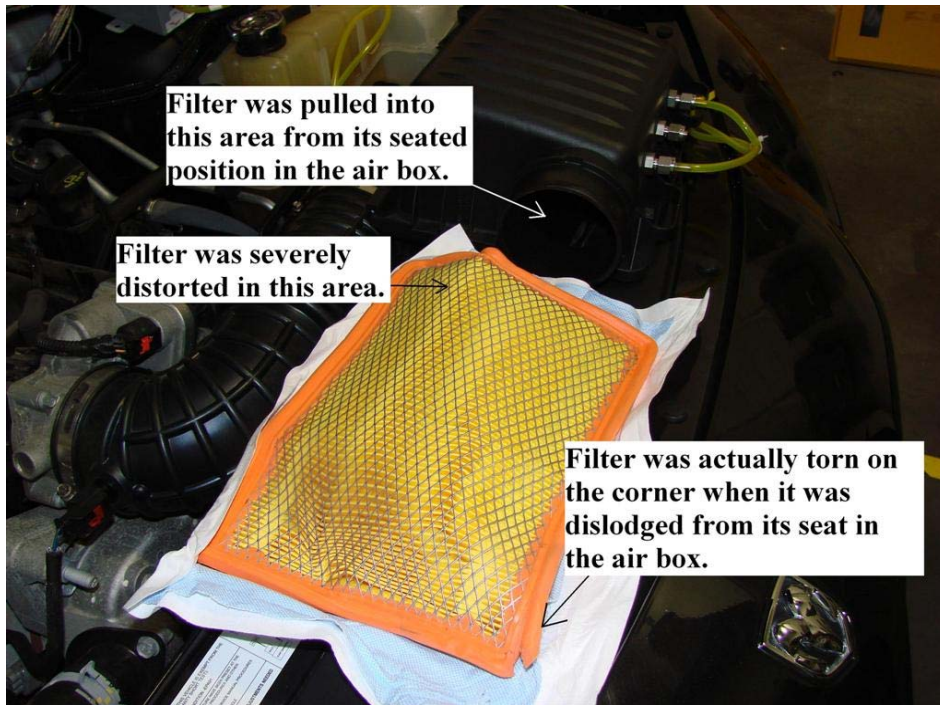
Fig. 3.6. Air filter damage from WOT testing 2006 Dodge Charger. Filter was damaged due to the pressure drop across the filter, resulting in the filter being torn out of its seat in the air box.

Also, for the Charger, under these acceleration conditions with the filter clogged, the pressure drop was so severe that the air filter was actually dislodged from its position in the air cleaner box and pulled into the intake hose. Fig. 3.6 shows the damage that was done to the air filter as a result of these clogged air filter WOT tests.

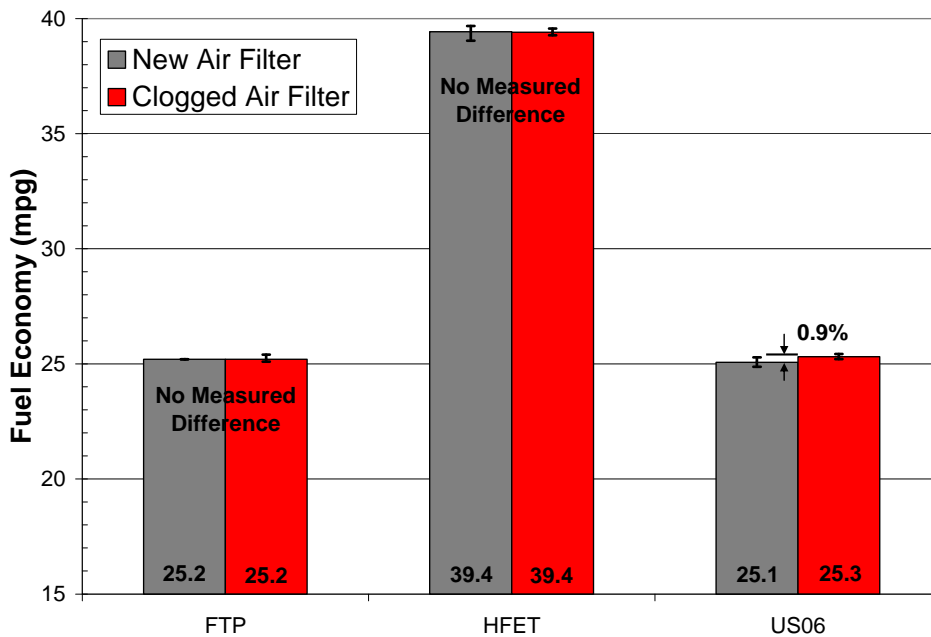
Fig. 3.8. Fuel economy for 2003 Toyota Camry. Data are averaged over the three tests conducted for each cycle and configuration. Range bars show the minimum and maximum for each data set.

Despite the filter restrictions, however, no significant changes in fuel economy were observed. Each vehicle was run through at least three rounds of FTP, HFET, and US06 tests with the new air filter, and the same protocol was repeated with the clogged air filter. The tests were conducted on consecutive days for each vehicle. This format was used to allow for the required soak time to perform a cold FTP each morning. The resulting fuel economy data for the vehicles are shown in Figs. 3.8, 3.9, and 3.10. Range bars in the figures show the minimum and maximum of the tests for each case, while the columns show the average. Test-to-test repeatability is within about 1.5%, and all of the variances between the new and clogged air filter cases are similarly within about 1.7%. The baseline fuel economies for the vehicles were all within 0–6% of unadjusted EPA certification database values (www.epa.gov) for similar vehicles.

The changes observed by clogging the air filter produced no significant effect on the fuel economy of the vehicles tested, when tested over these three standard cycles that represent a wide range of driving conditions. It is possible that there may be some isolated operating conditions under which the fuel economy may be more susceptible to a clogged air filter. However, such operating conditions are not likely to be consistent from vehicle to vehicle. The three driving cycles used here are representative of a wide range of driving conditions, as described in Sect. 1.

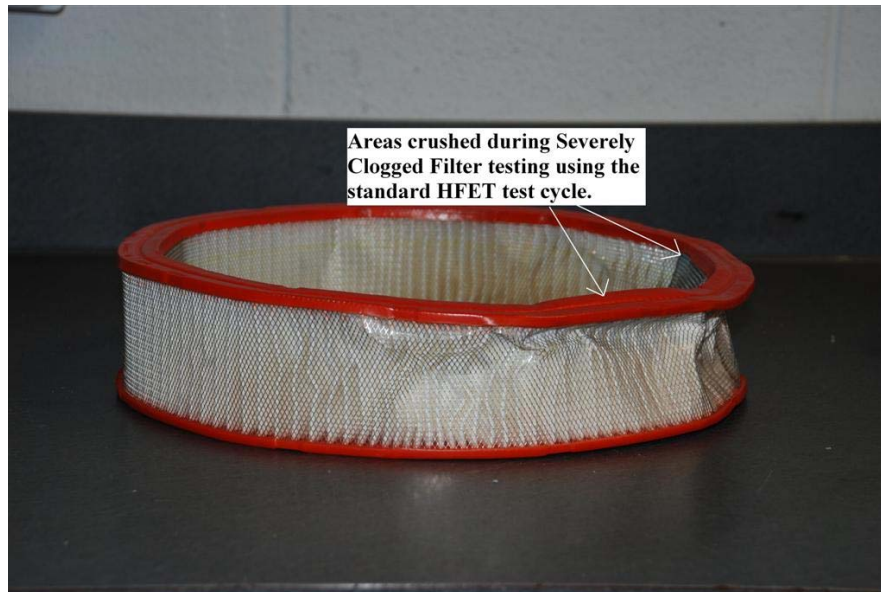
Fig. 3.18. Damaged air filter from severely clogged air filter testing, 1972 Pontiac Grandville.

The filter restriction in the Severely Clogged Air Filter Test 3 configuration (black column, Fig.3.17) was so severe that the driver had to consciously drive the vehicle in a manner that would not increase the throttle fast enough to cause a rich misfire condition during the HFET cycle. Once rich misfire was encountered, the vehicle was not able to maintain speed, and therefore, the test was invalid. The Filter Test 3 configuration also resulted in the air filter being crushed by the air filter cover. Figure 3.18 shows a picture of the air filter after removal of the shop towels.
