Effect of Intake Air Filter Condition on Vehicle Fuel Economy

**EFFECT OF INTAKE AIR FILTER CONDITION ON
VEHICLE FUEL ECONOMY**

Prepared by
OAK RIDGE NATIONAL LABORATORY
Oak Ridge, Tennessee 37831-6283
managed by
UT-BATTELLE, LLC
for the
U.S. DEPARTMENT OF ENERGY
under contract DE-AC05-00OR22725

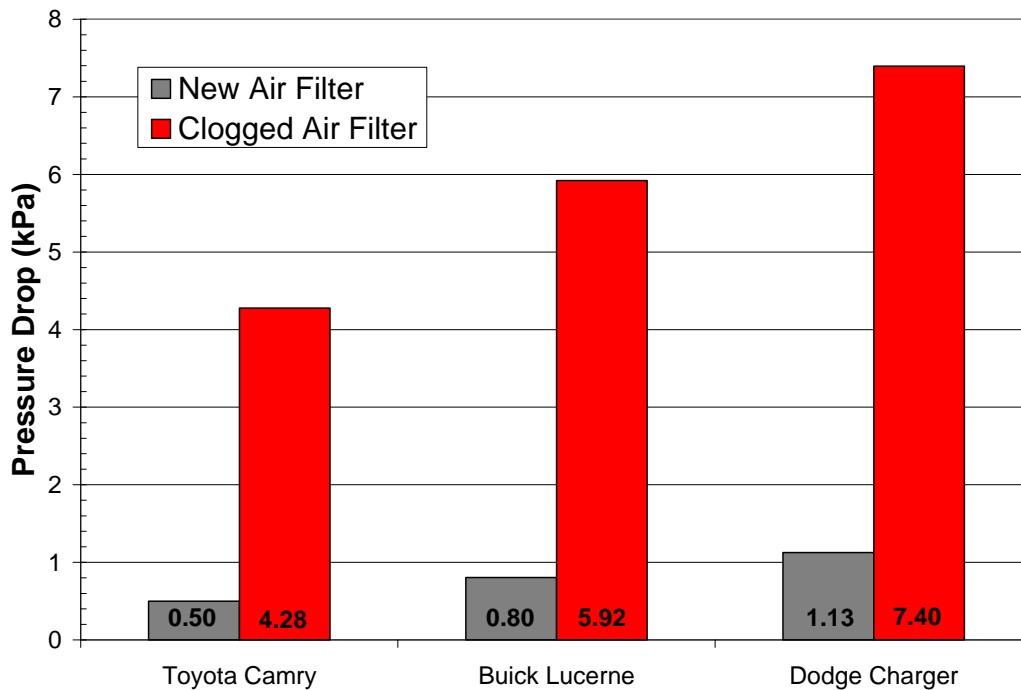
Fig. 3.5. Average maximum Outlet DP for SS WOT tests.

during the CRC E-60 WOT section of the test, was used to compare these vehicles, as shown in Fig. 3.4. The Outlet DP values for the SS WOT tests were all within the range of the sensor and are shown in Fig. 3.5.

For the Lucerne, the Outlet DP at 3000 RPM during the initial acceleration of the CRC E-60 WOT tests was in excess of 4 kPa for the clogged filter and less than 0.4 kPa for the new filter (Fig. 3.4). During the SS WOT tests the clogged filter created an Outlet DP in excess of 5.7 kPa, while the new filter Outlet DP was less than 0.9 kPa (Fig. 3.5).

For the Charger, the Outlet DP at 3000 RPM during the initial acceleration of the CRC E-60 WOT tests was in excess of 6.2 kPa for the clogged filter, while that for the new filter was less than 1.1 kPa under the same acceleration conditions (Fig. 3.4). During the SS WOT tests the clogged filter created an Outlet DP in excess of 7.2 kPa, while the new filter Outlet DP was less than 1.2 kPa under the same acceleration conditions (Fig. 3.5).

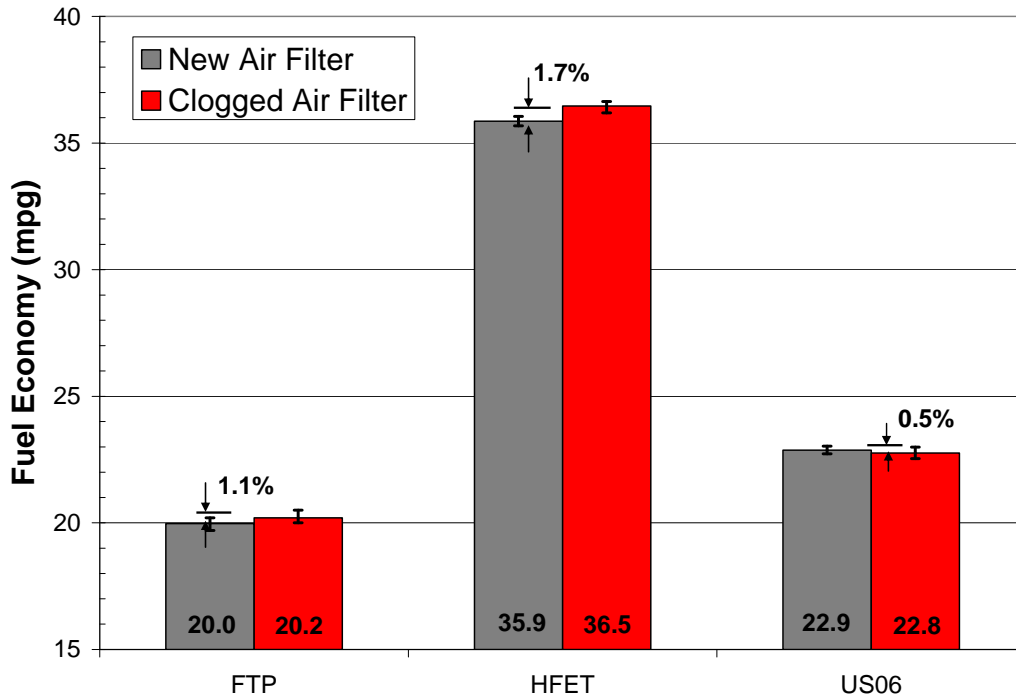
Fig. 3.9. Fuel economy for 2007 Buick Lucerne. Data are averaged over the four tests conducted for each cycle and configuration. Range bars show the minimum and maximum for each data set.

Despite the filter restrictions, however, no significant changes in fuel economy were observed. Each vehicle was run through at least three rounds of FTP, HFET, and US06 tests with the new air filter, and the same protocol was repeated with the clogged air filter. The tests were conducted on consecutive days for each vehicle. This format was used to allow for the required soak time to perform a cold FTP each morning. The resulting fuel economy data for the vehicles are shown in Figs. 3.8, 3.9, and 3.10. Range bars in the figures show the minimum and maximum of the tests for each case, while the columns show the average. Test-to-test repeatability is within about 1.5%, and all of the variances between the new and clogged air filter cases are similarly within about 1.7%. The baseline fuel economies for the vehicles were all within 0–6% of unadjusted EPA certification database values (www.epa.gov) for similar vehicles.

The changes observed by clogging the air filter produced no significant effect on the fuel economy of the vehicles tested, when tested over these three standard cycles that represent a wide range of driving conditions. It is possible that there may be some isolated operating conditions under which the fuel economy may be more susceptible to a clogged air filter. However, such operating conditions are not likely to be consistent from vehicle to vehicle. The three driving cycles used here are representative of a wide range of driving conditions, as described in Sect. 1.
