Effect of Intake Air Filter Condition on Vehicle Fuel Economy

Energy and Transportation Science Division

Date Published: February 2009

Prepared by
OAK RIDGE NATIONAL LABORATORY
Oak Ridge, Tennessee 37831-6283
managed by
UT-BATTELLE, LLC
for the
U.S. DEPARTMENT OF ENERGY
under contract DE-AC05-00OR22725

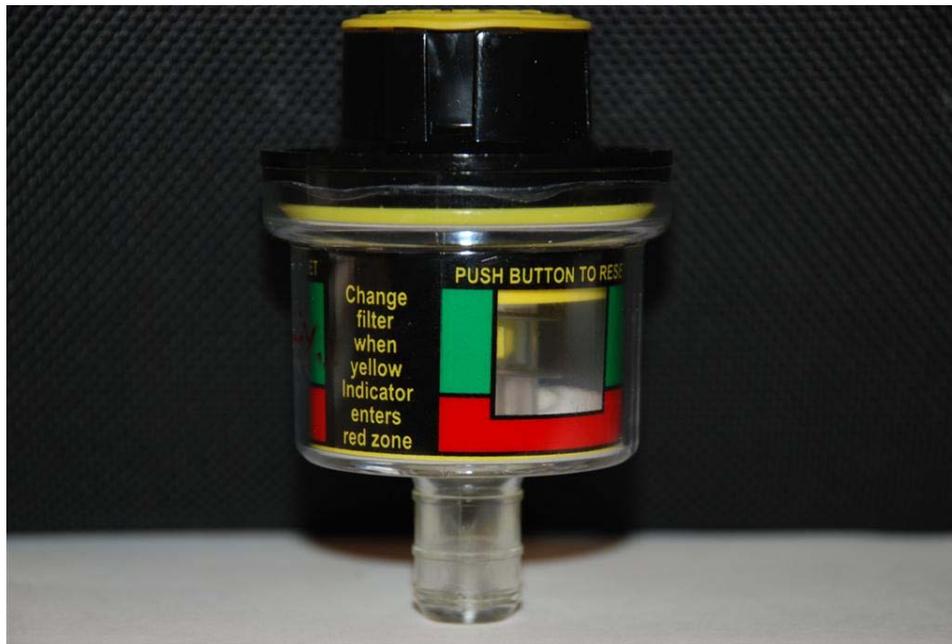
Fig. 2.2. Air filter indicator.

A factory OEM indicator was taken from a 2001 Chevrolet Silverado with 5.3L V8 and tested to find the Outlet DP required to “set” the indicator or move the yellow indicator into the red zone (see Fig. 2.2). Using a vacuum pump and water manometer to test the indicator, the authors determined that an Outlet DP of about 5.7 kPa was needed to set the indicator to the level corresponding to a clogged air filter.

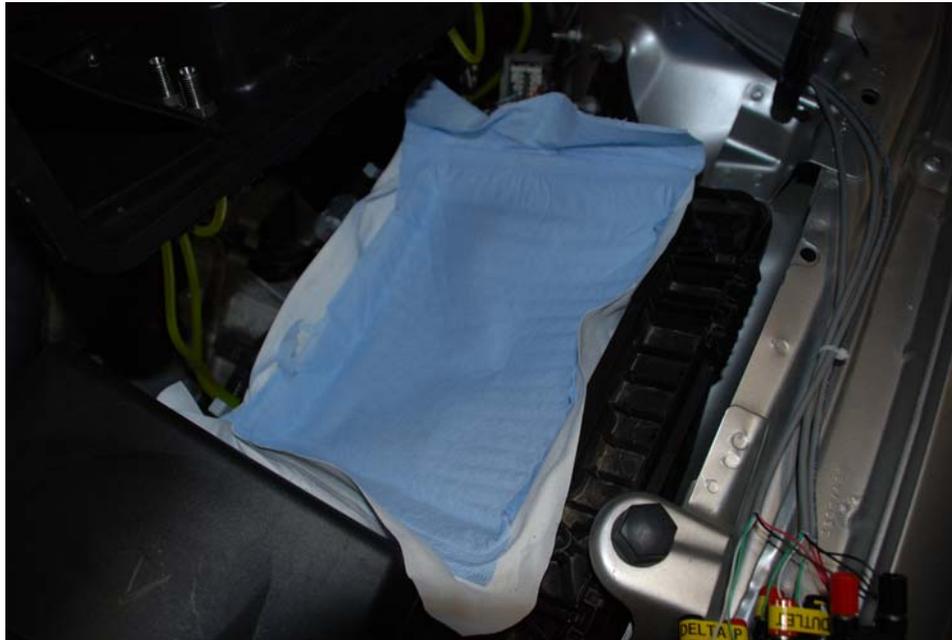
Fig. 2.3. 2007 Buick Lucerne filter restriction. Shop towels inserted into air box upstream of the air filter.

In all cases, the “new” air filter was a newly purchased aftermarket filter for that specific application. The simulated clogged air filter was another identical filter that was blocked off with a series of disposable shop towels to create the desired pressure drop. For the newer vehicles, the shop towels were placed in the air box on the upstream side of the air filter to increase the resistance of the air flowing through, as shown in Figs. 2.3 and 2.4. In the case of the 1972 Pontiac, the round filter was wrapped with shop towels to create the desired resistance, as shown in Fig. 2.5. Before the procedure for simulating a clogged filter was established, several filters were tested on the 2007 Buick. The OEM air filter was found to have a slightly higher pressure drop at WOT than several aftermarket air filters. The aftermarket filters were used for this testing to generate the largest difference between “clean” and “clogged” for these experiments.

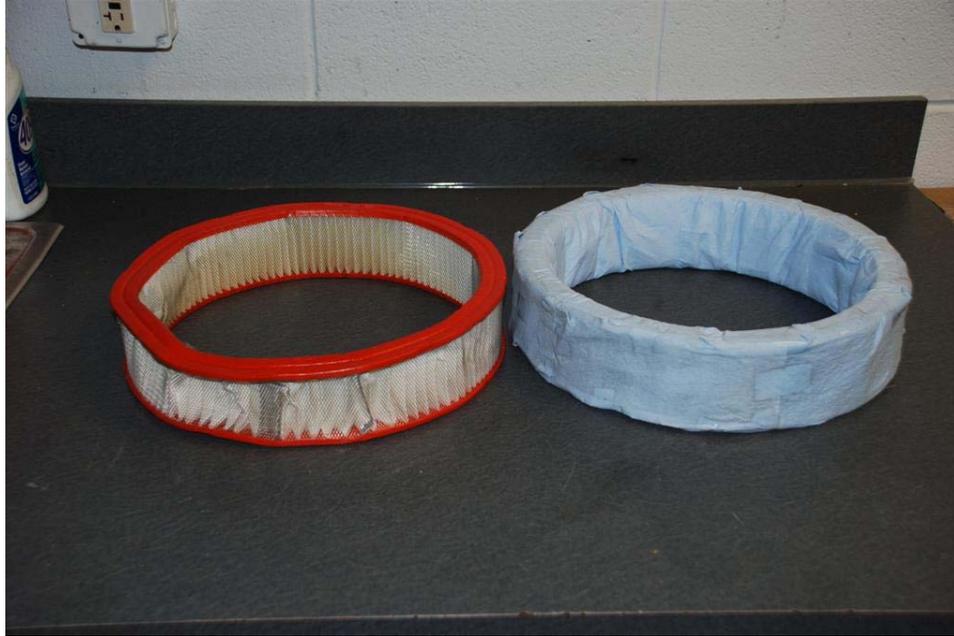
Fig. 2.5. 1972 Pontiac Grandville air filter. Filter on the left shows damage that occurred during “severely clogged” filter testing (see Sect. 3.3.1).

Wide-open throttle (WOT) tests were used to measure the changes in the filter pressure drop (Outlet DP). In a real-world application, the vacuum needed to set one of the air filter indicators would likely occur under heavy acceleration, such as merging onto an interstate, or climbing a steep grade. Therefore the level of restriction was set, using an artificial clogging technique described below, to achieve the desired Outlet DP during a WOT acceleration from idle to approximately 85 mph or a steady-speed (SS) WOT test in which the dynamometer was held at a fixed speed, 65 mph, and the throttle was held open for 10 seconds. Using these test procedures, the 2007 Buick Lucerne was configured to achieve an Outlet DP of approximately 7.0 kPa under the WOT acceleration and approximately 5.7 kPa under the SS WOT. Once the method for achieving this restriction was developed, it was used with each vehicle. Using this approach, the V8-equipped Dodge Charger showed a slightly higher Outlet DP than the V6 Lucerne, and the I4 Camry showed a slightly lower Outlet DP. The 1972 V8 Pontiac was restricted in a similar manner and level. It is important to note that all the modern vehicles used rectangular cartridge style air filters (Figs. 2.3 and 2.4), while the 1972 Pontiac used the cylindrical filter element common in that era (Fig. 2.5).
